**CARBON FIBER INSTALLATION AT  
INTERMOUNTAIN POWER SERVICE  
CORPORATION  
UNIT 1 - MARCH 1988  
84", 114" & 120" Diameter PCCP  
Pipe Sections**

**CARBON FIBER INSTALLATION REPORT**

**COOLING WATER SYSTEM – UNIT 1**

**KPFF CONSULTING ENGINEERS, INC.**

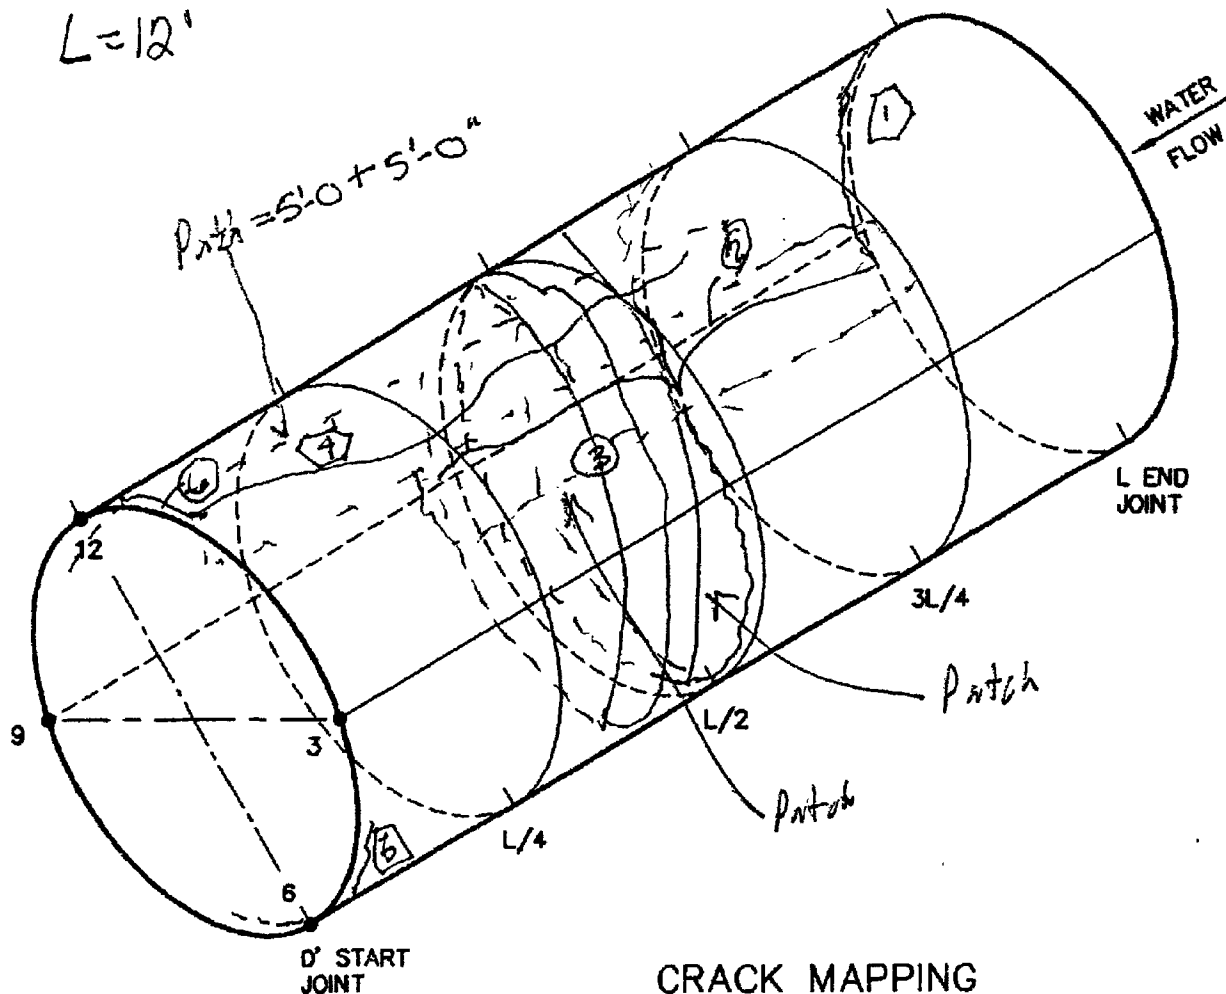
SPOOL NO. 535

CRACK NO.	LOCATION	DESCRIPTION	REMARKS
①	9 o'clock to 12 o'clock	jt crack	$L = 7'-0"$
②	from $L/4$ to $L$ @ 9 o'clock	longitudinal crack - mc	<del>2'-6"</del> Patch = $9'-0"$
③	3 o'clock all the way around to 6 o'clock between $L/4$ + $L/2$	spiral crack	$L = 27'-10"$ Patches = $8'-0" + 21'-0"$
④	1 o'clock to 11 o'clock from $L/2$ to $0$	longitudinal - mc crack off top 3'	$10'-0" = L$ Patch = $(2) 5'-0" + \text{Patches}$
⑤	7 o'clock to 5 o'clock @ start joint	jt crack / hoop - mc crack	$L = 7'-6"$
⑥	10 o'clock to 12 o'clock	hoop crack - mc	$L = 3'-0"$

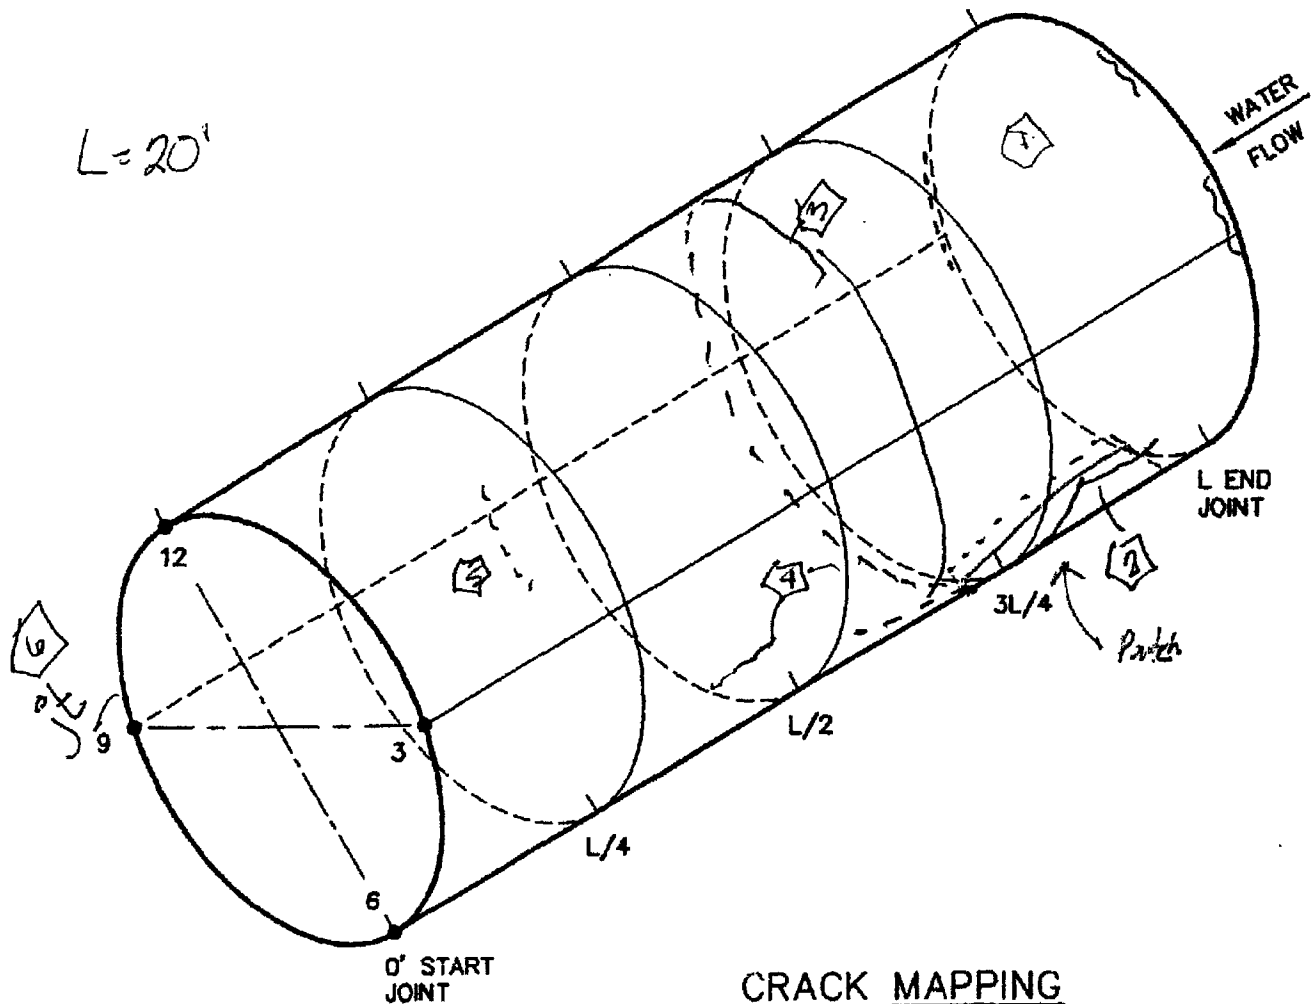
SPOOL NO. 533

⑪ @ end joint 11:00-10:00 joint crack 1/2 hoop

⑫ @ end joint 9:00 joint crack 10"

⑬ @ end joint 3:00-7:00 joint crack 1/2 hoop 144"

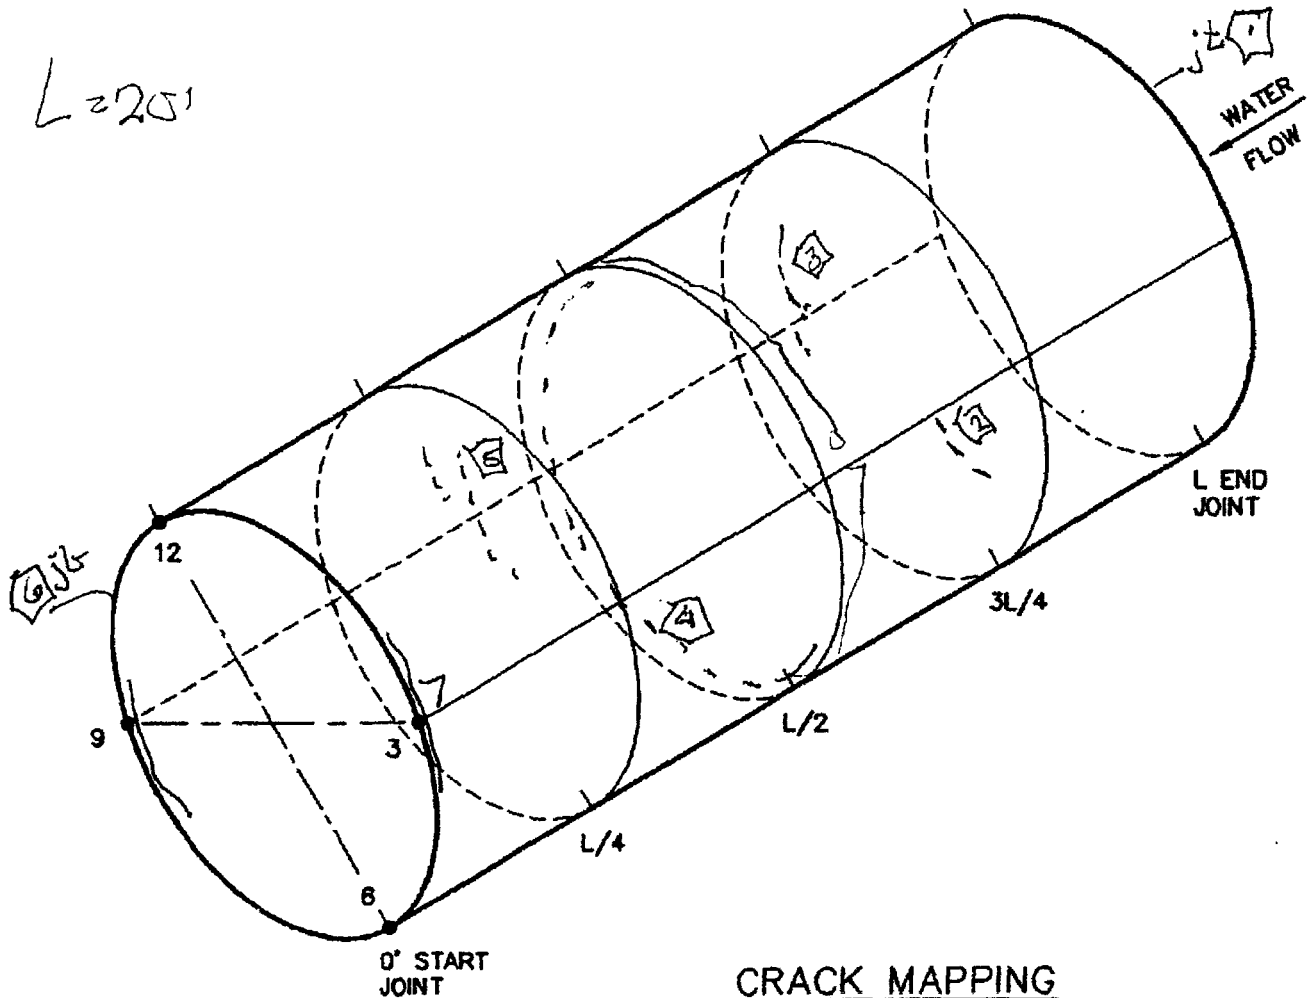
SPOOL NO. 430

CRACK NO.	LOCATION	DESCRIPTION	REMARKS
1	L/4	11-1	3'-0"
2	3L/8	11-3	6'-0"
3	L/2	9-5	13'-0"
4	3L/4	4-7	moisture coming thru 5'-0"
5	7L/8	4-7	moisture coming thru 5'-0"
6	JOINT		22'-0"
7	JOINT		22'-0"

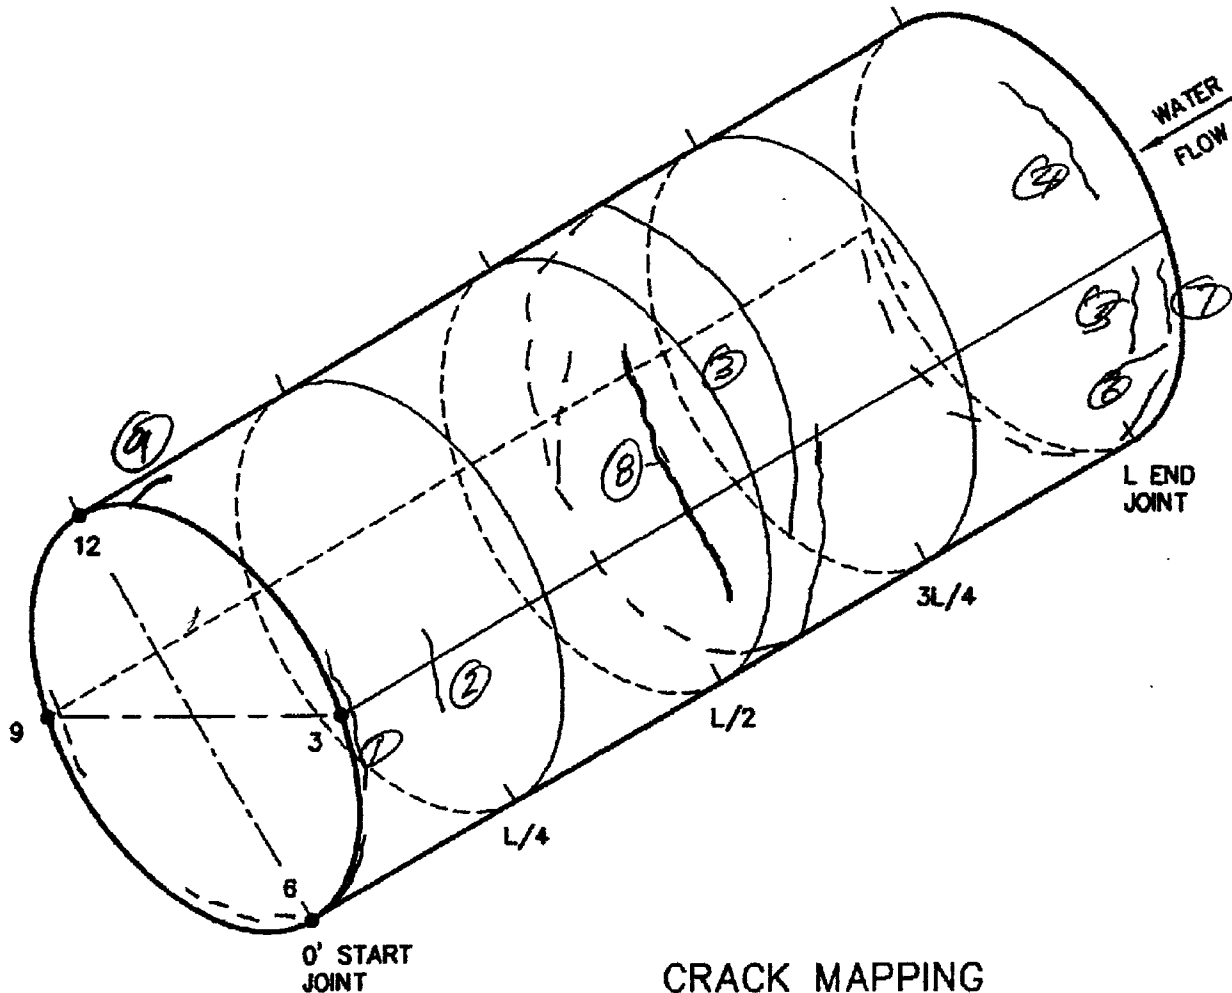
CRACK NO.	LOCATION	DESCRIPTION	REMARKS
1	At Joint	15' 2-1/4" 7	
2	Deep Crack	20' 6-12-5	
3	Longitudinal crack	10' 7	
4	At Joint	9' 5-7

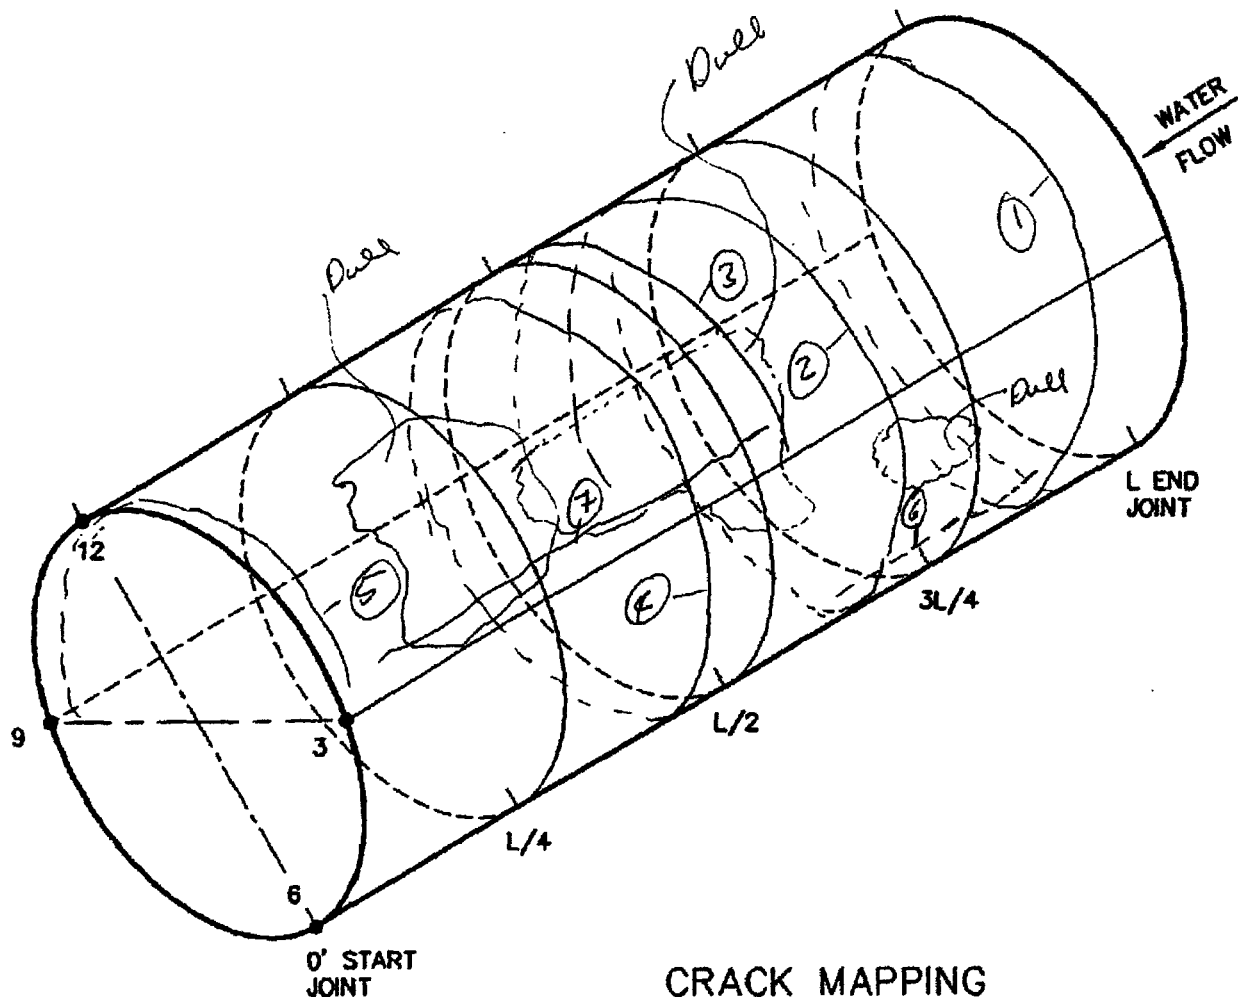
CRACK NO.	LOCATION	DESCRIPTION	REMARKS
1	3/4 - END 6 o'clock to 7 o'clock	spiral crack	136 INJECTION
2	L/2 - 3L/4 11 o'clock to 9 o'clock	spiral crack	↓
3	L/2 - 3L/4 9 o'clock to 3 o'clock	hoop crack	PATCH
4	L/4 - L/2 9 o'clock to 9 o'clock	spiral crack	INJECTION
5	0 start - L/4 3 o'clock to 9 o'clock	joint crack	↓
6	L END to 3L/4	length crack	7 feet
7	start to mid L/2		7 feet ↓

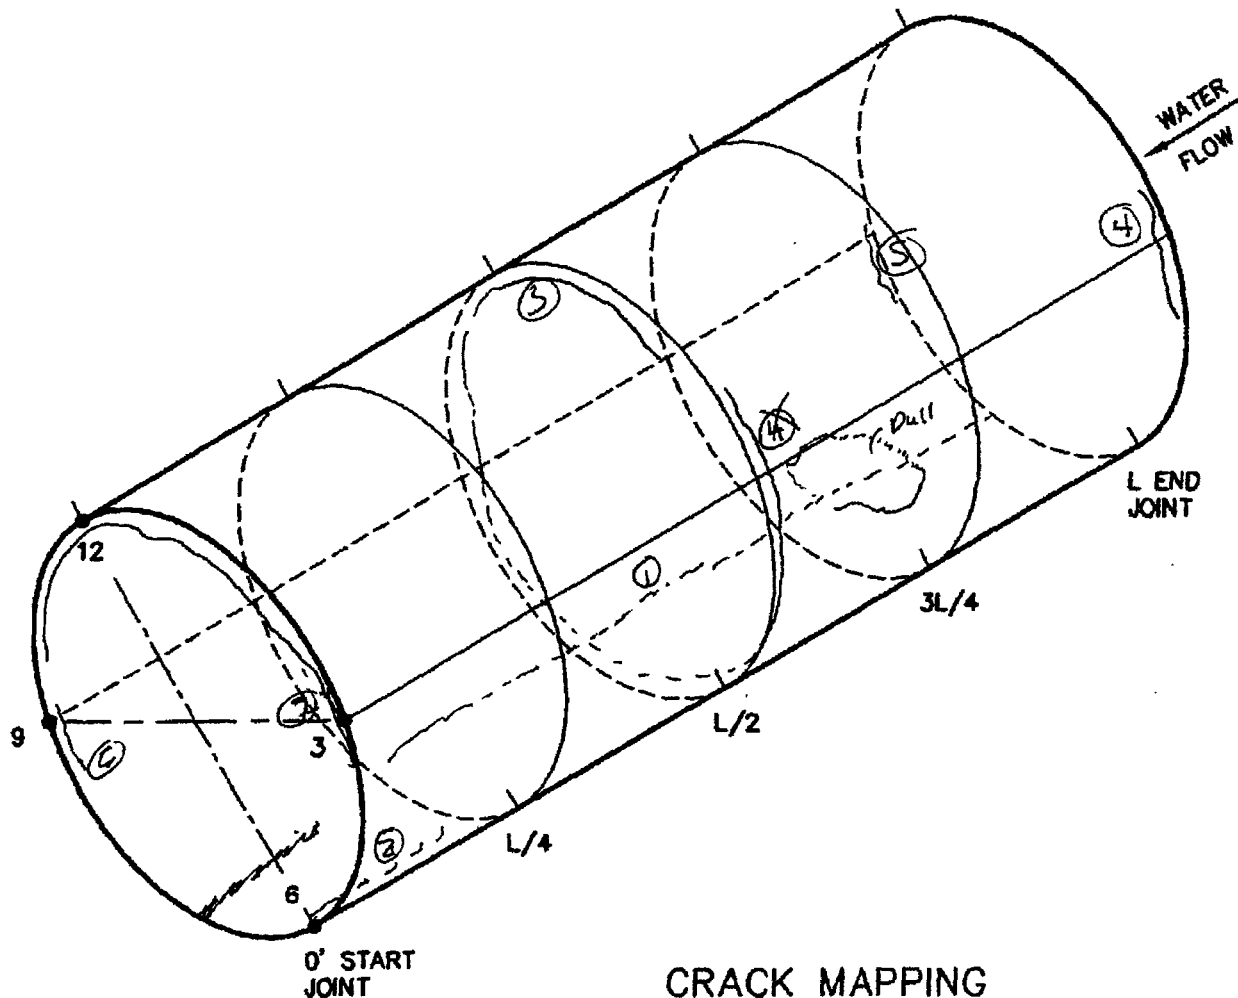
CRACK NO.	LOCATION	DESCRIPTION	REMARKS
①	645 L/4 TO joint	11' patch needed horiz. crack	PATCH
②	600 beg. of joint (0)	5'-4" patch needed horiz. crack	PATCH
③	L/2	<del>micro crack</del> circumference spiral micro crack	
<del>④</del> ④	end joint 27"	<del>micro crack</del> 3 1/2'	
⑤	end joint 16"		
⑥	start joint 34"		
⑦	" " 22"

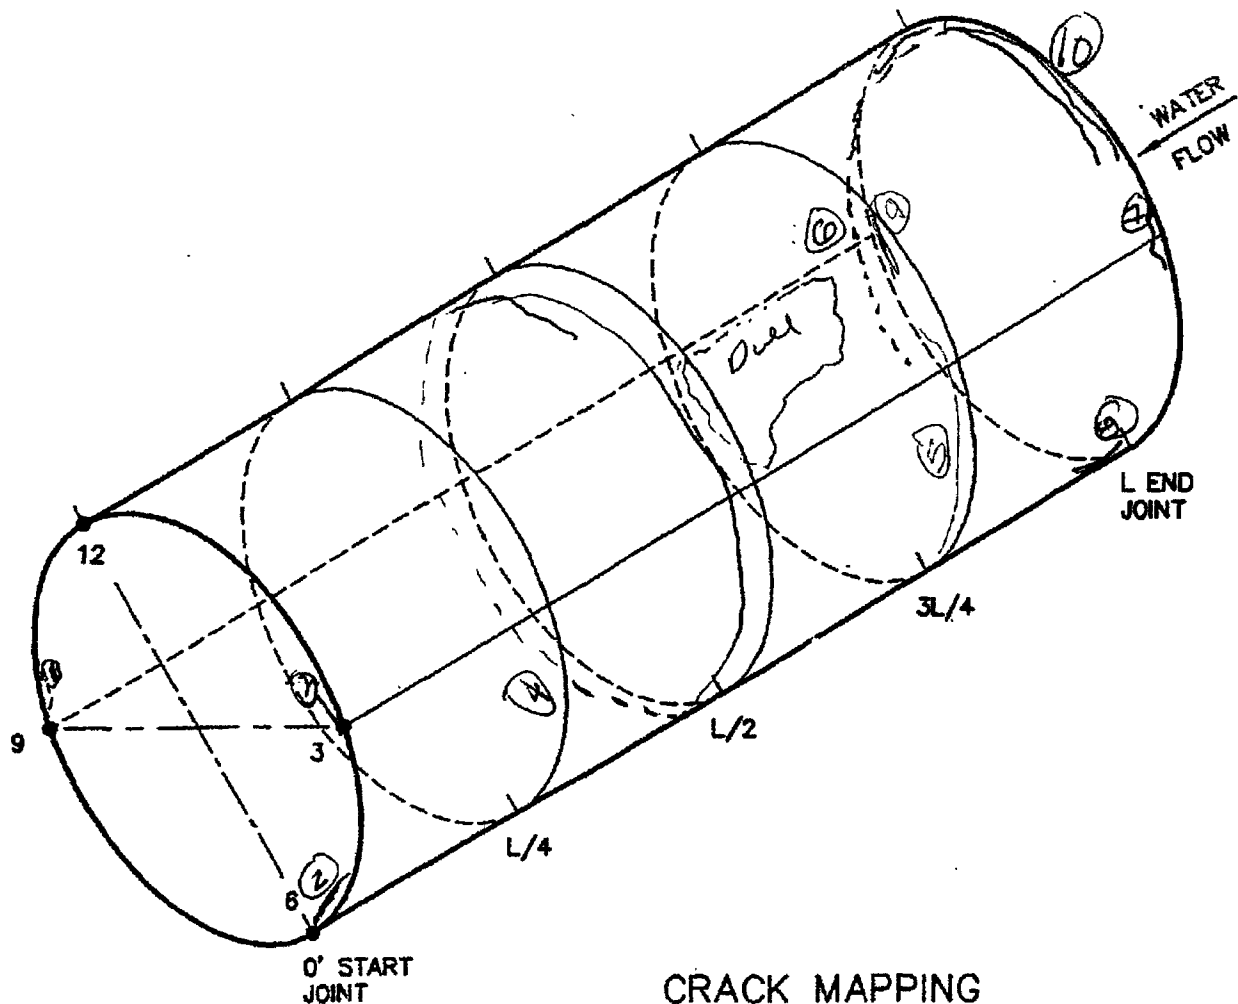
CRACK NO.	LOCATION	DESCRIPTION	REMARKS
①	4/2 - 3L/4 12h	spiral crack	<del>later to be removed</del>
②	4/4 - 4/2 12h	spiral crack	
③	9 o'clock 3L/4 to mid start	length crack	8 feet
④	<del>for 1/4</del> 8 to 10 o'clock L END	joint crack	2 feet

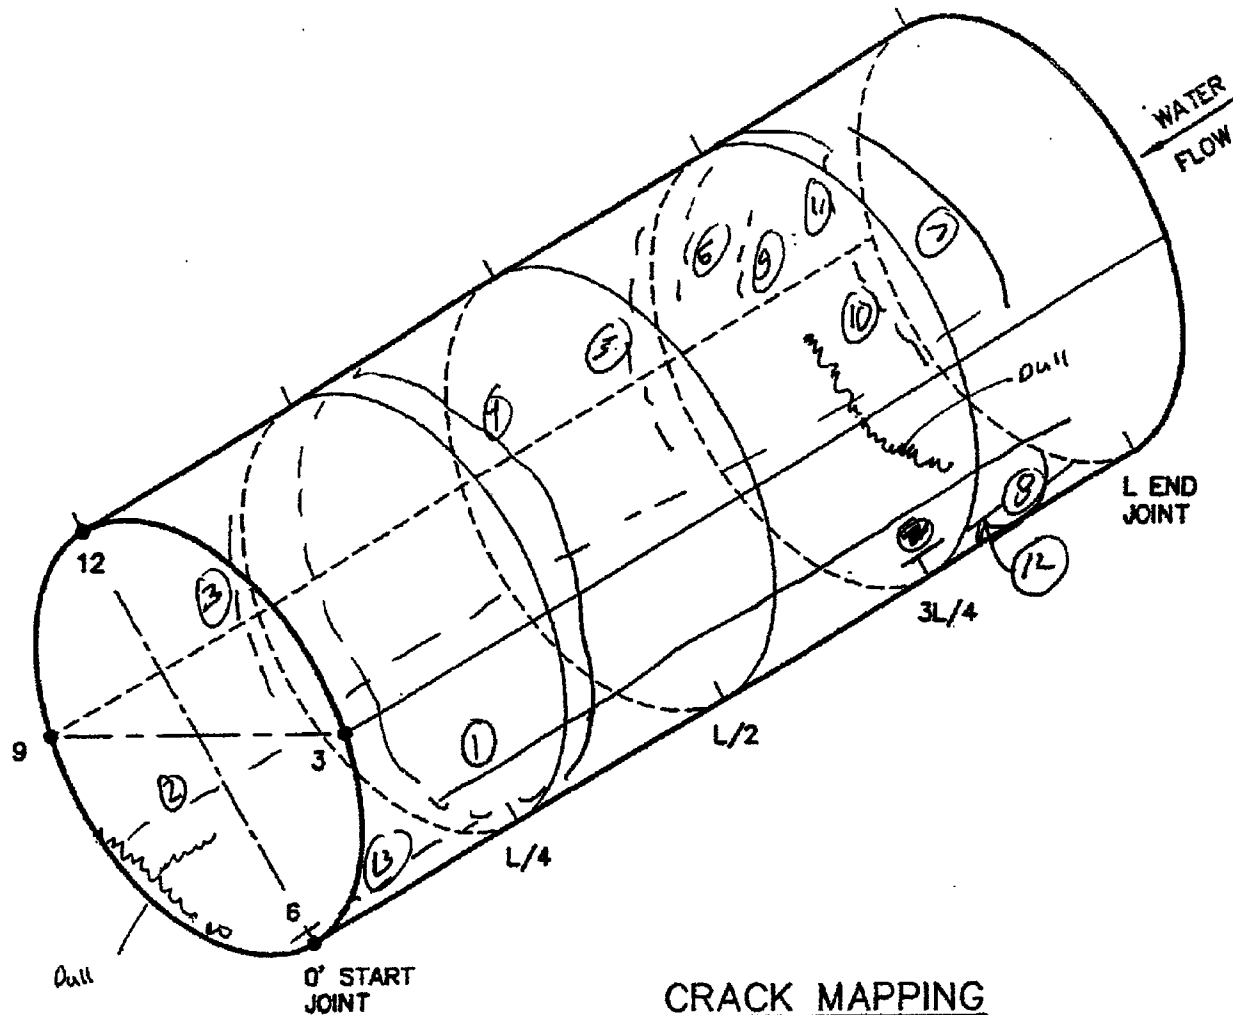
CRACK NO.	LOCATION	DESCRIPTION	REMARKS
(1)	3-9 16'	ST. CRACK	
(2)	1-3 10'	MICROCRACK	
(3)	6-2 20'	HOOP CRACK	
(4)	2-5 8'	MICROCRACK

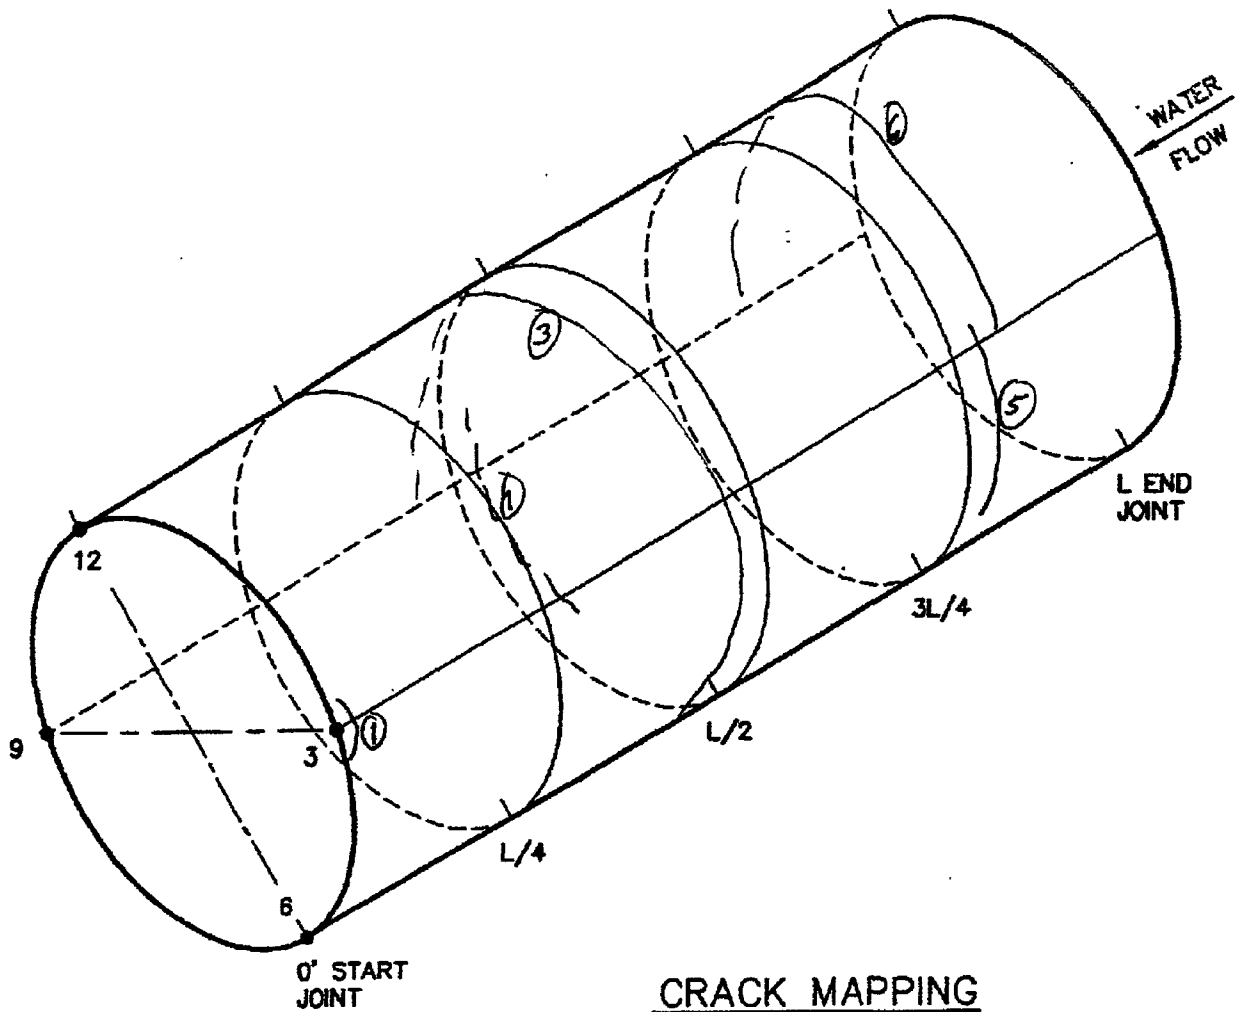
CRACK NO.	LOCATION	DESCRIPTION	REMARKS
①	3 1'	JT. CRACK	
②	5-7 8'	JT. CRACK	
③	9-6 24'	HOOP CRACK	
④	6-9 8'	MICRO CRACK	
⑤	3-5 7'	MICRO CRACK	
⑥	9-3 16'	HOOP CRACK

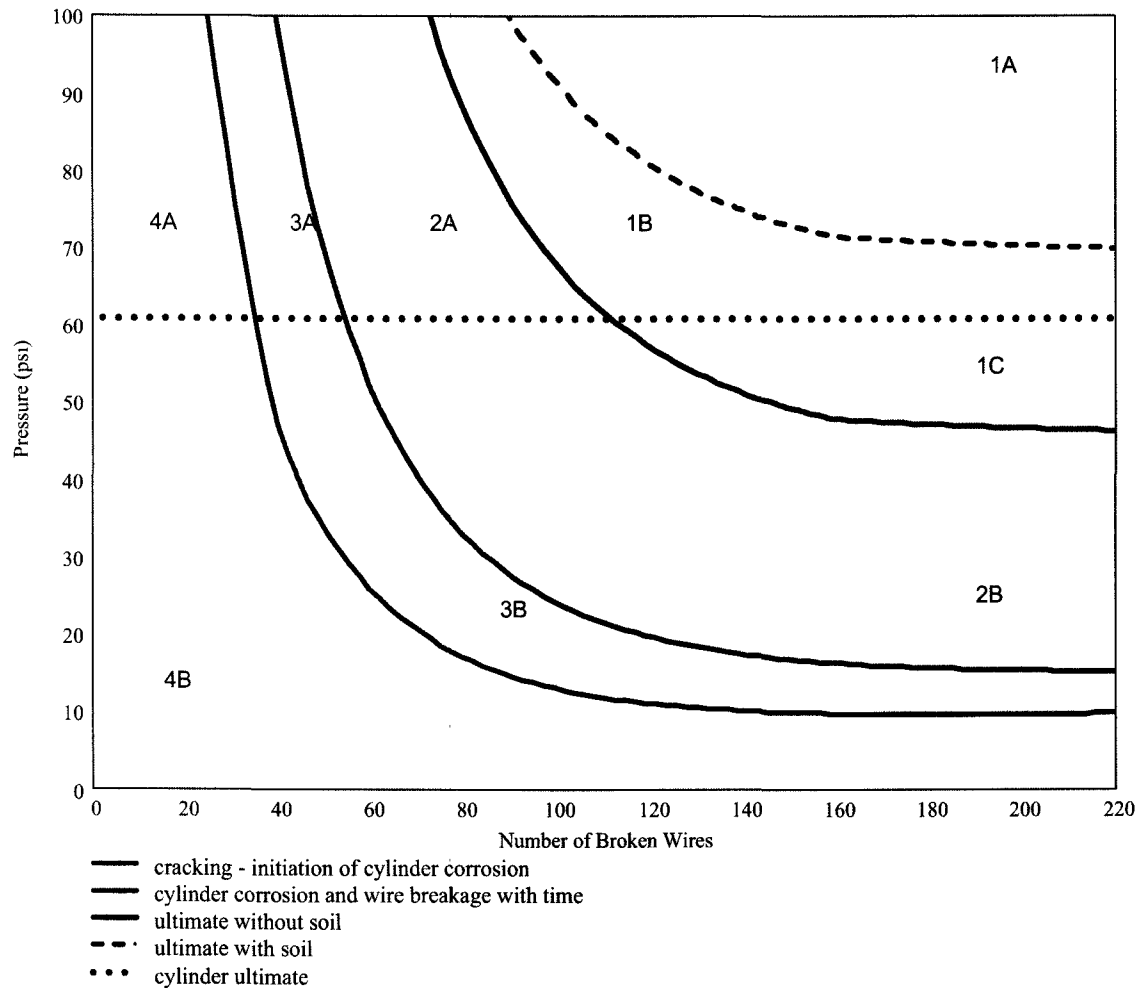
**Figure 4 – Risk of Rupture and Repair Priorities for 84 in. Diameter Pipe Design 1**  
 (Segment A-84-1:  $P_w = 32\text{ psi}$ ,  $P_{\max} = 48\text{ psi}$ , and Segment B-84-1:  $P_w = 36\text{ psi}$ ,  $P_{\max} = 54\text{ psi}$ , 12 ft of Soil Cover)

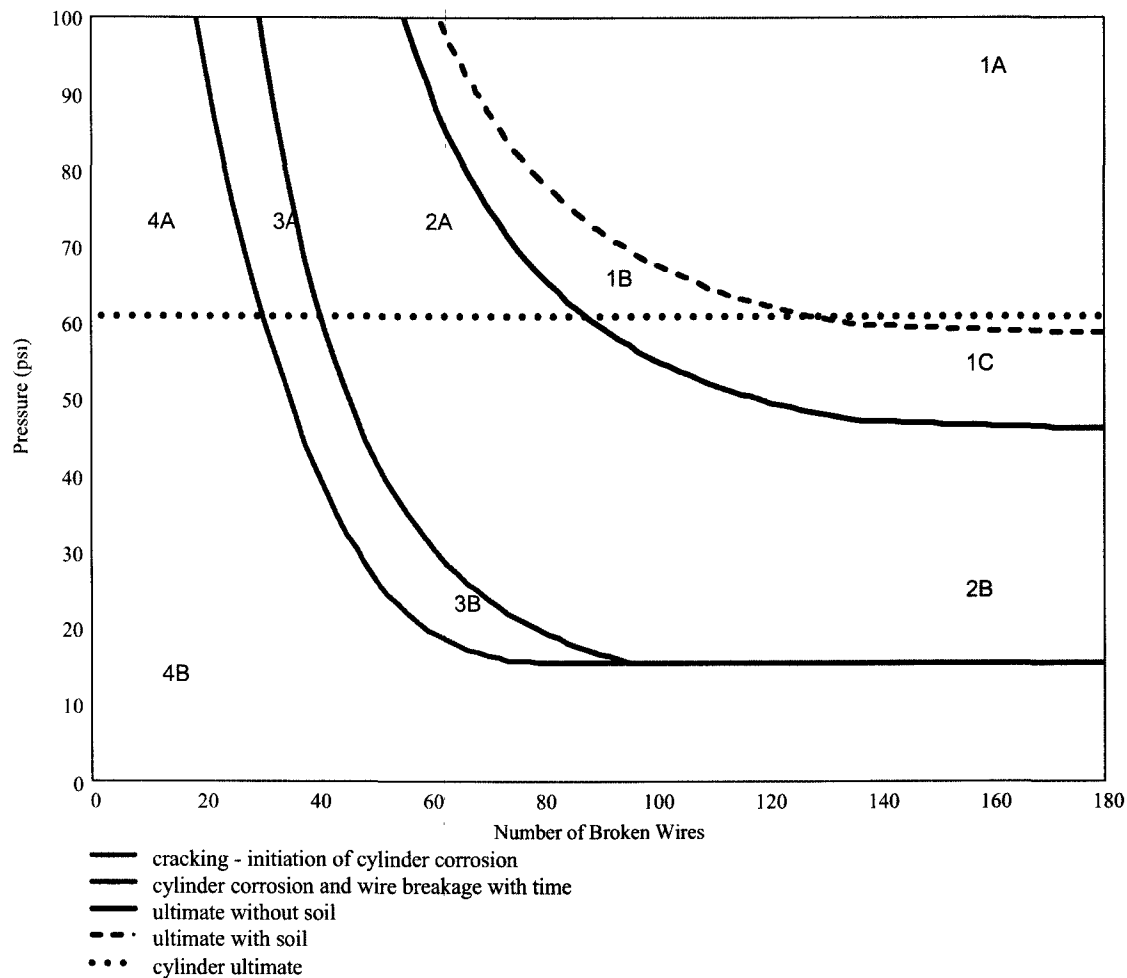
**Figure 5 – Risk of Rupture and Repair Priorities for 84-in. Diameter Pipe Design 2**  
**(Segments A-84-2 and A-84-3:  $P_w = 27 \text{ psi}$ ,  $P_{max} = 41 \text{ psi}$ , 7 ft of Soil Cover)**

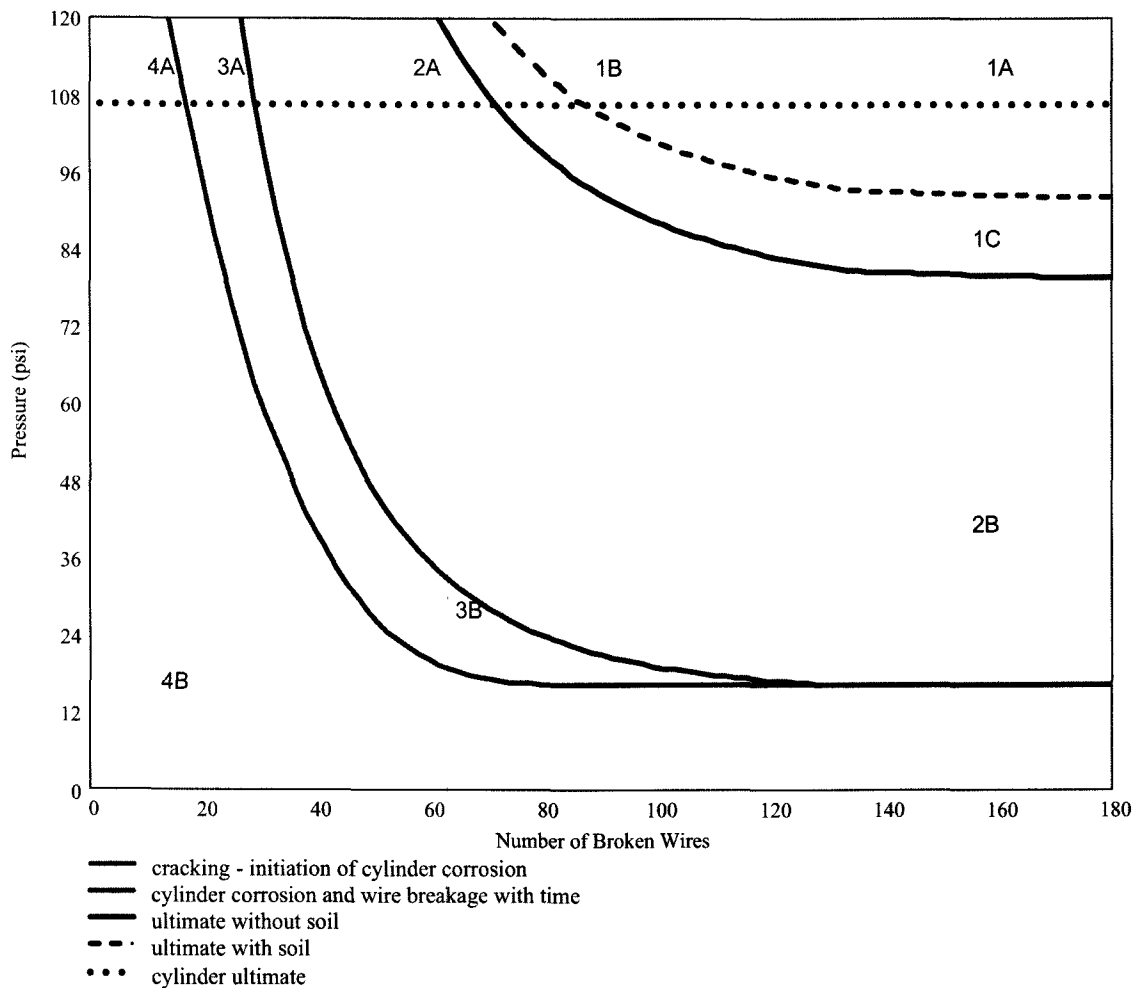
**Figure 6 – Risk of Rupture and Repair Priorities for 84 in. Diameter Pipe Design 2  
 with gage 12 steel cylinder  
 (Segments A-84-2 and A-84-3:  $P_w = 27\text{ psi}$ ,  $P_{\max} = 41\text{ psi}$ , 7 ft of Soil Cover)**

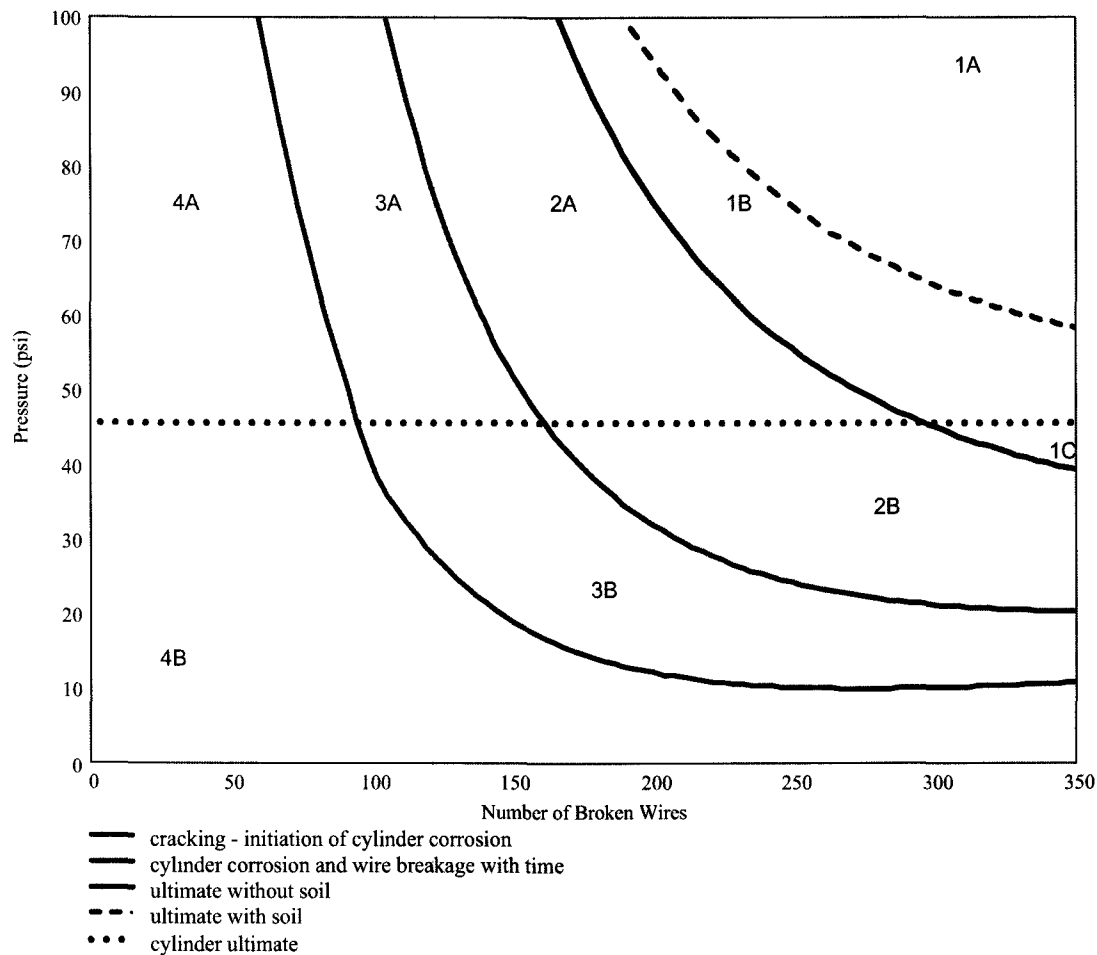
**Figure 7 – Risk of Rupture and Repair Priorities for 114 in. Diameter Pipe Design**  
 (Segment A-114:  $P_w = 32\text{ psi}$ ,  $P_{max} = 48\text{ psi}$ , and  
 Segment B-114:  $P_w = 36\text{ psi}$ ,  $P_{max} = 54\text{ psi}$ , 10.5 ft of Soil Cover)

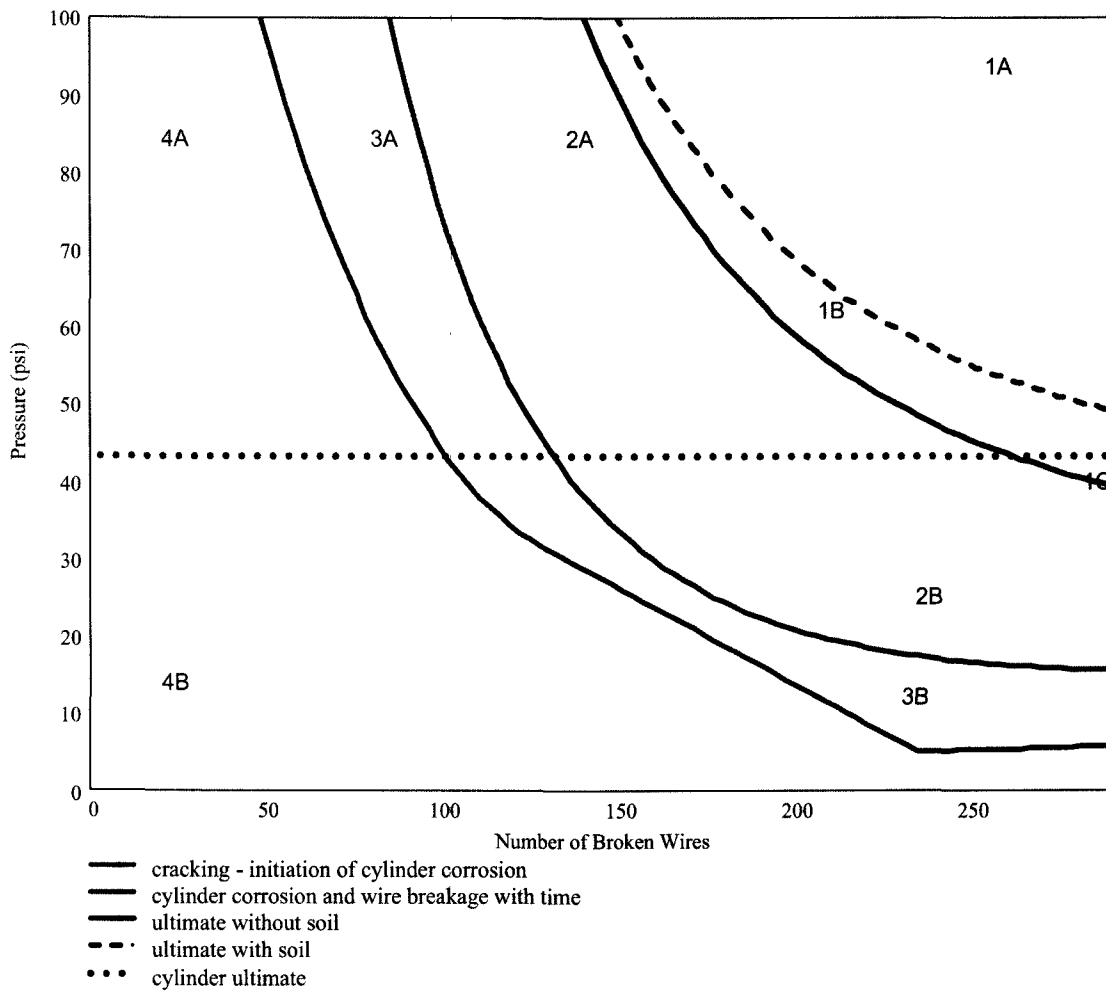
**Figure 8 – Risk of Rupture and Repair Priorities for 120 in. Diameter Pipe Design**  
**(Segment A-120:  $P_w = 32\text{psi}$ ,  $P_{\max} = 48\text{psi}$ , 5 ft of Soil Cover)**

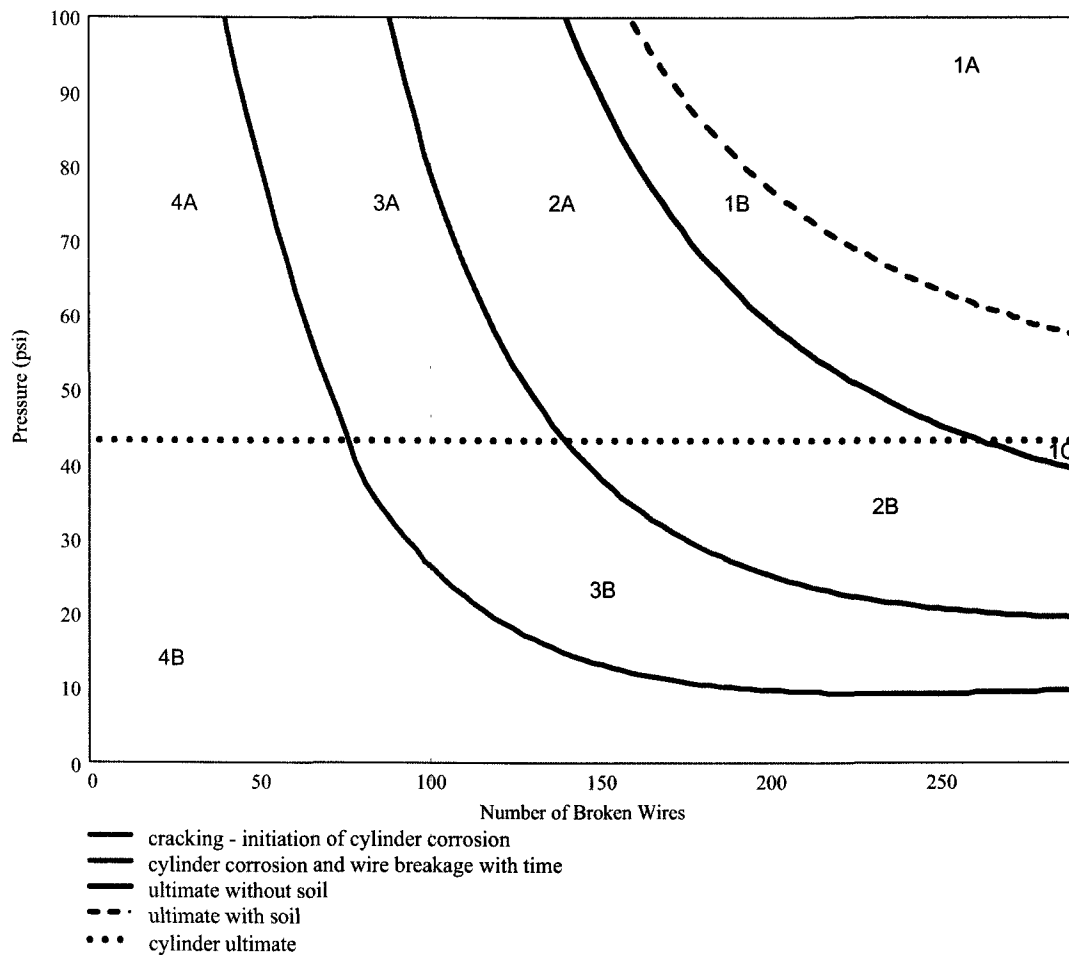
**Figure 9 – Risk of Rupture and Repair Priorities for 120 in. Diameter Pipe Design**  
 (Segment A-120:  $P_w = 32\text{ psi}$ ,  $P_{\max} = 48\text{ psi}$ , and  
 Segment B-120:  $P_w = 36\text{ psi}$ ,  $P_{\max} = 54\text{ psi}$ , 10 ft of Soil Cover)

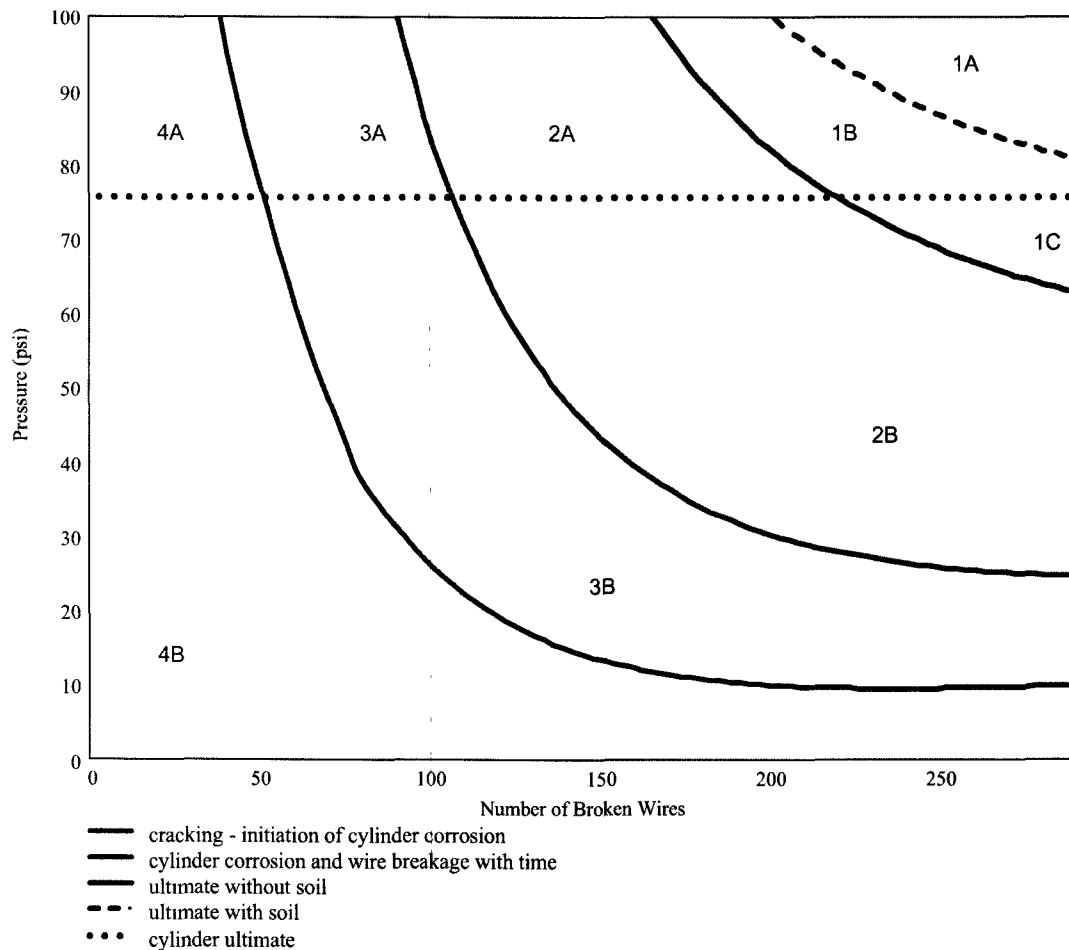
**Figure 10 – Risk of Rupture and Repair Priorities for 120 in. Diameter Pipe Design**  
 (Segment A-120:  $P_w = 32\text{ psi}$ ,  $P_{max} = 48\text{ psi}$ , and  
 Segment B-120:  $P_w = 36\text{ psi}$ ,  $P_{max} = 54\text{ psi}$ , 10 ft of Soil Cover, gage 12 Steel Cylinder)

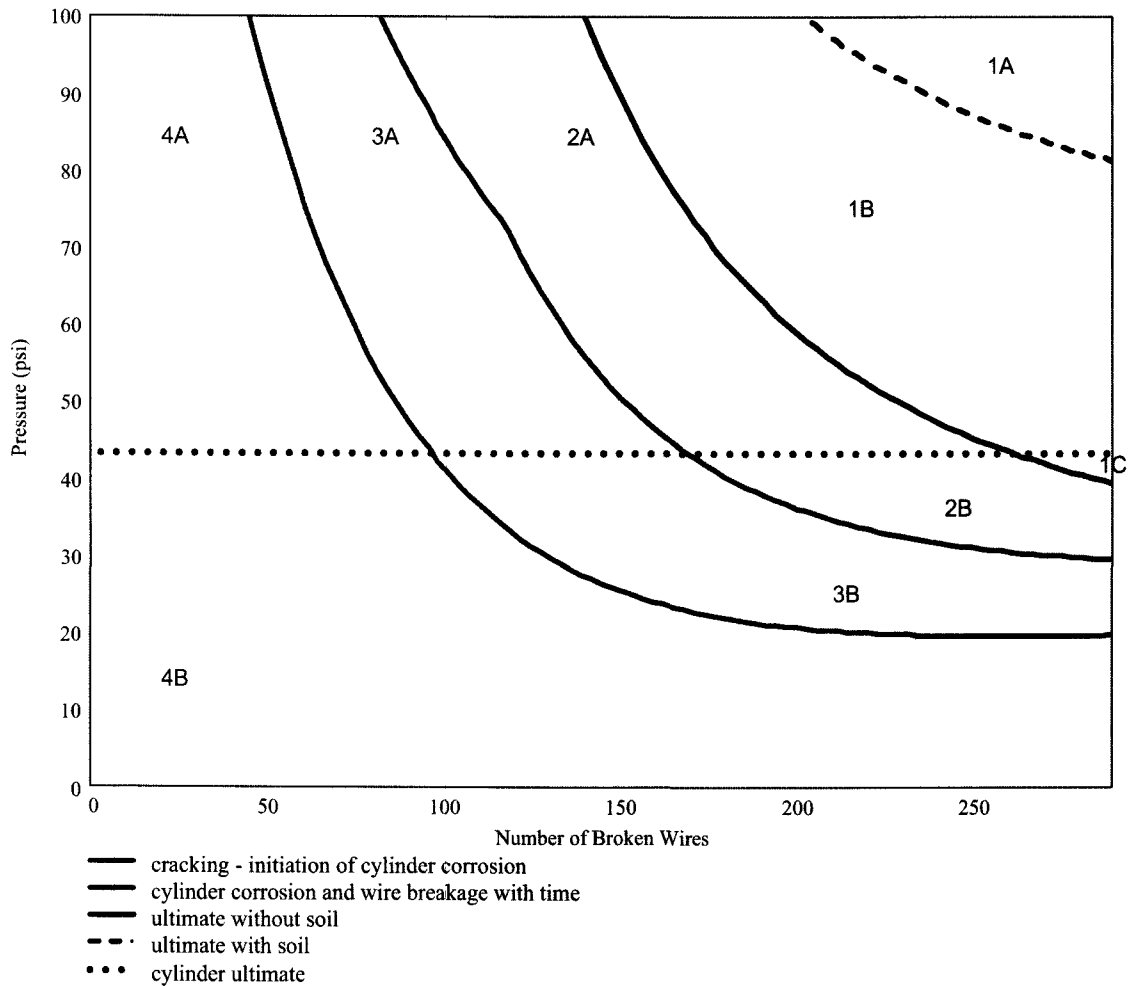
**Figure 11 – Risk of Rupture and Repair Priorities for 120 in. Diameter Pipe Design**  
 (Segment A-120:  $P_w = 32\text{ psi}$ ,  $P_{\max} = 48\text{ psi}$ , and  
 Segment B-120:  $P_w = 36\text{ psi}$ ,  $P_{\max} = 54\text{ psi}$ , 20 ft of Soil Cover)

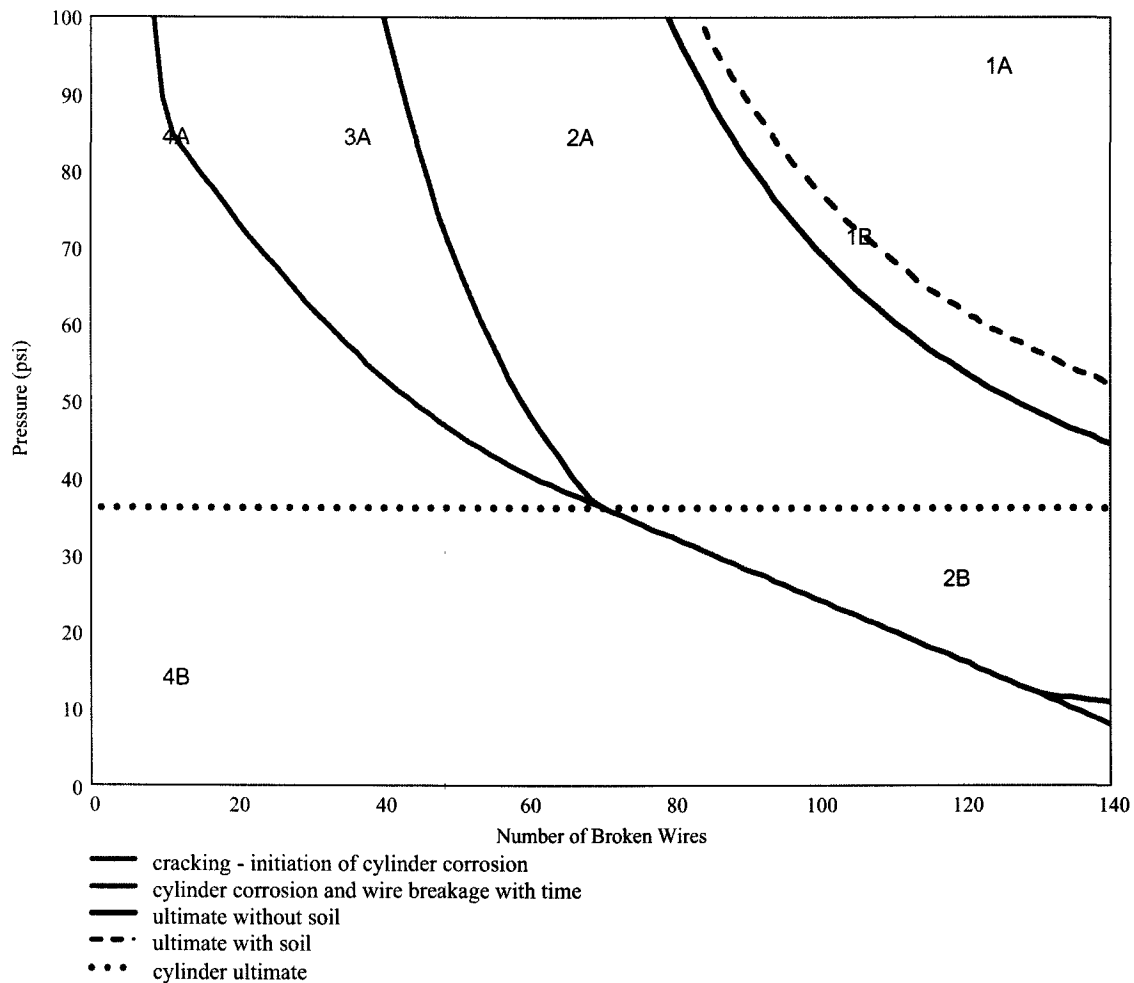
**Figure 12 – Risk of Rupture and Repair Priorities for 144 in. Diameter Pipe Design**  
**(Segments C-144 and D-144:  $P_w = 12\text{ psi}$ ,  $P_{max} = 18\text{ psi}$ , 3 ft of Soil Cover)**

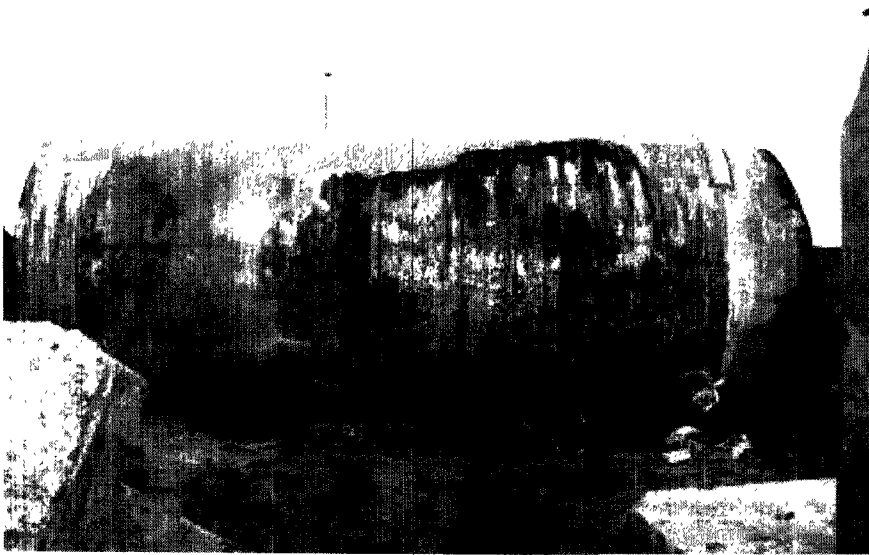
**Photo 13**

84 in. Pipe Number 476 (Photos 13 through 18): This pipe has not been inspected by RFEC/TC. We observed two areas of broken wires: an approximately 12 ft-8 in. long segment of coating and prestressing wires had spalled from the end of the pipe near the end close to a 45° elbow (Photos 13 and 14), and an approximately 4 ft long area near the other end of the pipe (Photo 16). Some coating pieces were observed under the pipe and some coating may have spalled when the pipe was moved. There was an approximately 1/8 in. wide crack in the core along the length of the BWZ (Photos 14 and 15). A piece of the core was removed to expose the steel cylinder, and only minor surface corrosion was observed on the steel cylinder (Photos 17 and 18).

84 in. diameter Pipe #476.  
Spalled coating over most of  
the pipe length.
